Caple, Chris (1999) 'The Cathedral doors.', Durham archaeological journal., 14-15 . pp. 131-140.

THE DURHAM CATHEDRAL DOORS

by C. Caple

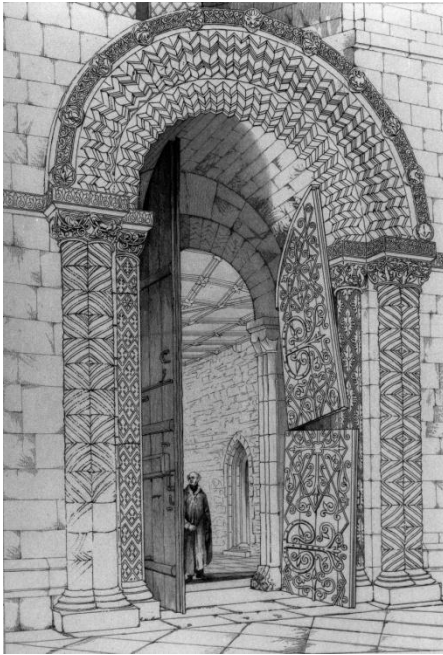
Figure 1: South (Monk's) Door: *Engraving from Billings 1843*

Though little has happened to the south (monk's) doors, at some point before the 19th century the west leaf of the door was cut completely in half and additional hinges added to the lower and upper halves in order to create a smaller convenient door to permit access between the nave of the cathedral and the cloister.

Note the curve backed 'wedged ledges' on the back of the door, though details of the jointing to the vertical planks are not accurately drawn

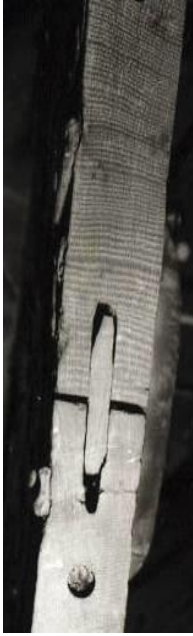
The leaves of the north door of Durham Cathedral are composed of a series of substantial planks which have grooves or mortices cut into their sides, into which are slotted free tongues or tenons, separate long thin strips of wood, which run the length of the plank, Figure 3. The leaf of each door is composed of 4 or 5 planks, with 3 or 4 free tongues or tenons. Three thin tapering horizontal ledges are present on the back of the door to hold the vertical planks together. The ledges are roughly semi circular in cross section and are attached to the planks having been slid into shallow dove-tailed grooves which have been cut across the full width of the back of each door plank. Thus the 'wedged ledges' hold the door planks firmly in position without any need for nails. The door with its ledges partially cut into the vertical planking is both thinner and lighter than other medieval doors. The use of the countersunk 'wedged ledges' is paralleled by Hewett (1980, 1982) in the doors of Eastwood, Heybridge and possibly Elmstead churches in Essex all of which are believed to date from the later half of the 12th century. Hewett's drawn description of the Durham cathedral doors (Hewett 1985) which indicates tongued planking is incorrect and should be modified to the free tenon format, Figure 3. Hewett (1980, 1985) gives no other examples of doors made with free tenons running the length of the planks, though short free tenons are used to join planks edge to edge on doors such as those of Kempley Church which are dated to circa AD 1100. The south door of

The radiocarbon samples S1 and S2 from the South (Monks) Door Plank 2 (Q8795) with dates of 1190+/-70 BP and 1070+/-65 BP have 72 rings between their mid points. Calibrating using the program OxCal 2.18 (Bronk Ramsey 1995), with calculations performed at an internal resolution of 1 year using the decadal calibration of Stuiver & Kra (1986) and a known difference of 72 years between the two dates, gives a calendar age for S1, at 95% confidence, as AD 756-960. The mid ring of S1 is at least 113 rings (possibly up to 123) from the outermost ring on the plank, giving a best estimate for the outer ring of AD 869-1073 (or slightly later). This is entirely consistent with the dendrochronological date from the Queens University laboratory of AD 1045 for the outermost ring of South Door Plank 2.

Figure 3: Cross Section Through Plank 2 (Q8795), West Leaf of the South (Monk's) Door: Photograph by Trevor Woods, Department of Archaeology, University of Durham
Note the free tenons between the mortised planks and the circular holes resulting from the removal of the samples for radiocarbon dating.

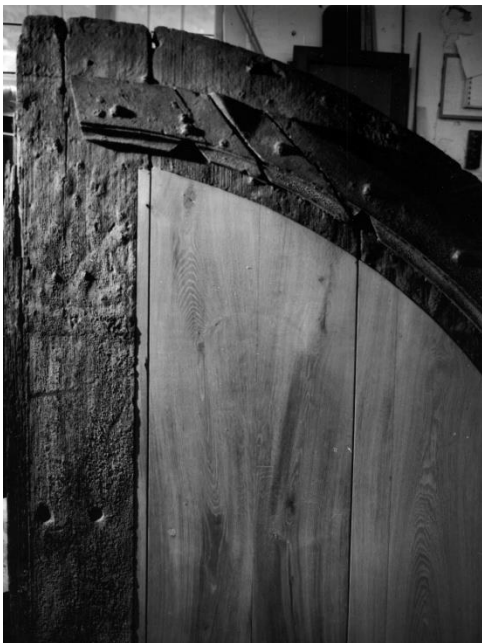
Figure 4: Upper front face of the West Leaf of the North Door during restoration.
Photographed in raking light by Trevor Woods, Department of Archaeology, University of Durham. Note the corroded nailshanks and raised ridges of the original strapwork

to advise on this project, that the paint on the north door should not be stripped off, but that a more subtle approach should be used. The initial tests suggested that little or nothing could adhere to the degraded wax which covered the present door surface, therefore, the initial work focused on removing this degraded, 20th century, outer coating. Initial attempts were made to find a solvent to dissolve the outer wax coat with a range of solvents: Industrial Methylated Spirits, Trichloroethane, Acetone, White Spirit, Toluene, had no effect, whilst a powerful dichloromethane based solvent such as 'Nitromors' removed the paint layer beneath as well as the wax layer. Thus solvents were not the answer. Eventually it was found that the flaking wax layer had become brittle with age and could be removed with an air abrasive operating at low pressure (Clogg pers. comm.). The door was subsequently cleaned of its wax layer by conservators using air abrasive systems (Hanna 1996). The cleaned surface of the door is now being monitored to see if it remains in a stable condition or whether a reversible protective polymer coating needs to be applied.

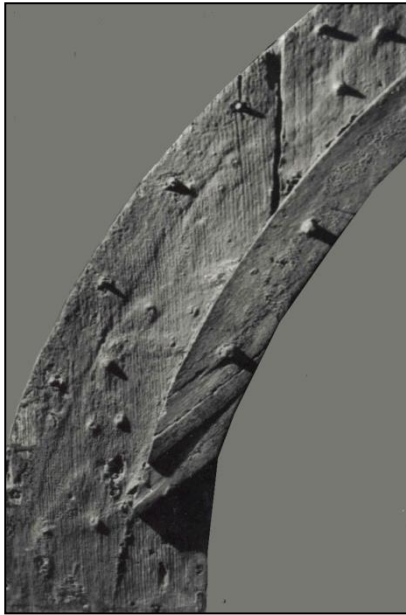
Figure 5: Upper front face of the East Leaf of the North Door during restoration.
Photographed in raking light by Trevor Woods, Department of Archaeology, University of Durham. Note the corroded nailshanks and raised ridges of the original strapwork
